New York State Department of Transportation  
Yellow Flag NB2358W020

BIN: 1065318

Feature Crossed: 6TH AVENUE

Location: Span 164, Girder G11 at Pier 164.

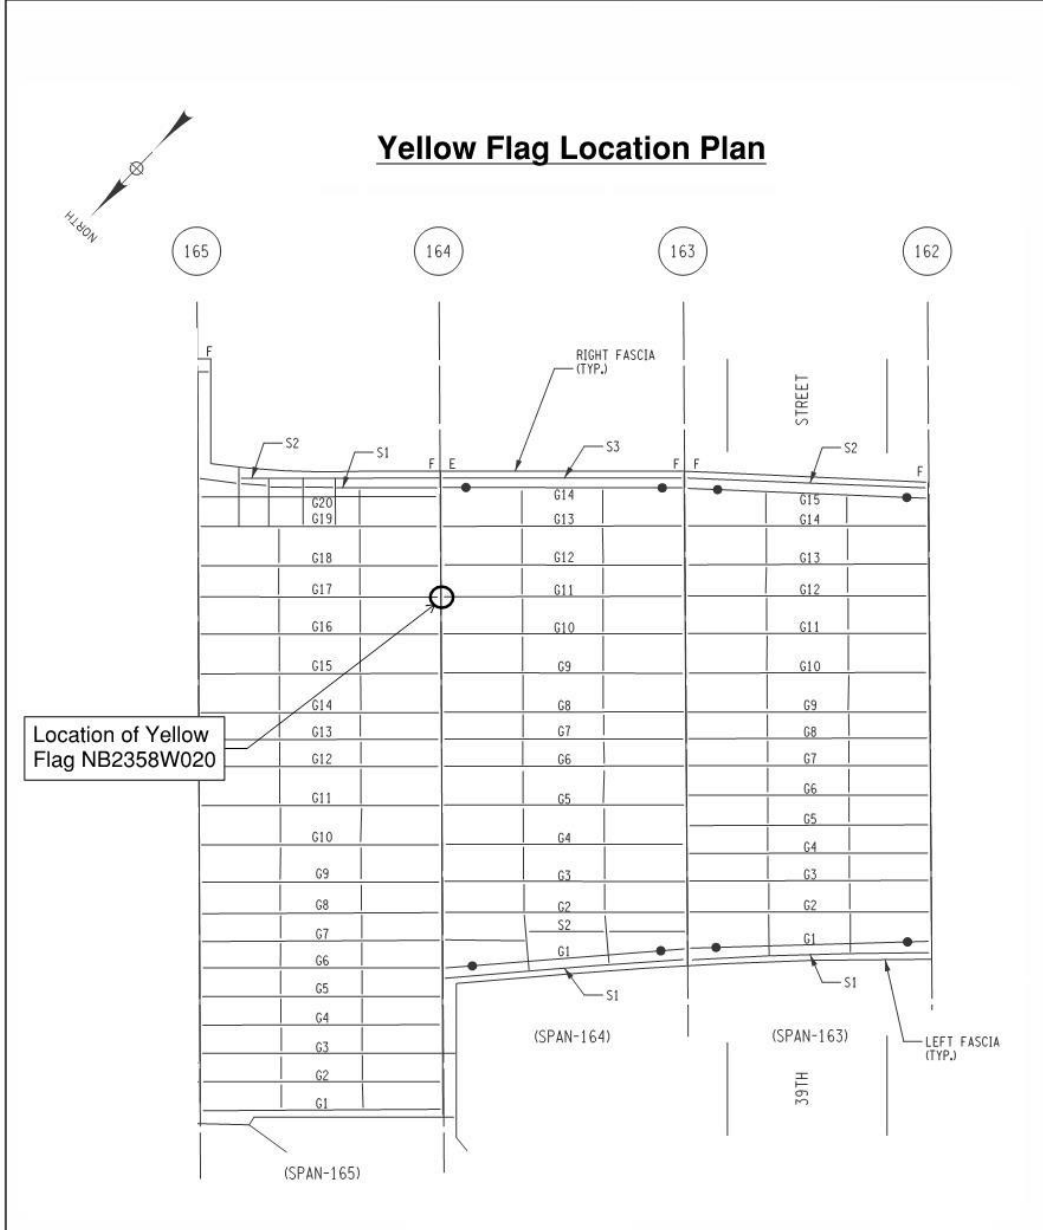
Photo Number: **1**

**Attachment Description: Flag Location Plan**

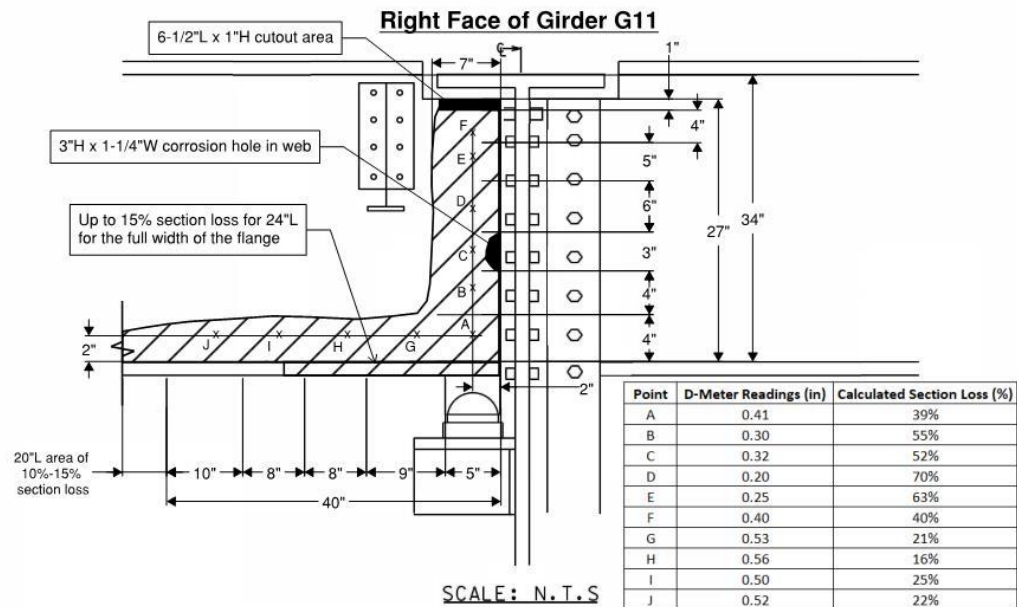
Photo Number: 2

The end of Girder G11 in Span 164 at Pier 164 exhibits severe section loss for the full height of the web above the bearing behind the guide angles for 27" high x 7" wide with 0.20"-0.41" remaining thickness measured (RTM), resulting in approximately 39% to 70% section loss with average 54% section loss for full girder web height. The lower web of the girder above the bottom flange exhibits 10%-25% section loss for 60"L x 4"H area with 47% localized section loss in the 8" high web area above the bearing (average 25% section loss in the lower web area). (Photos #4 and #5) The girder web exhibits one corrosion hole for 3"H x 1-1/4"W at the girder end behind the guide angle approximately 8" from the bottom flange (Photo #6). The top of the web at the end of the girder adjacent to the top cope exhibits 6-1/2"L x 1"H cut out area (Photo #7). The bottom flange of the girder exhibits up to 15% section loss for 24"L for the full width of the flange (Photo #8). The overall shear web area section loss is approximately 62%. The overall web bearing area section loss is approximately 23%. (refer to Flag Condition Sketch Photo #2 for more details)

**Section Loss Calculations:**

$$((27'' \times 0.667'') - 6.89 \text{ in}^2) / (27'' \times 0.667'') \times 100 = 62\%$$

$$((40'' \times 0.667'') - 20.5 \text{ in}^2) / (40'' \times 0.667'') \times 100 = 23\%$$

$$((8'' \times 0.667'') - (4'' \times 0.41'' [\text{Point A}] + 4'' \times 0.30'' [\text{Point B}])) / (8'' \times 0.667'') \times 100 = 47\%$$

Average section loss for full web height (Points A to F):  $(39\% + 55\% + 52\% + 70\% + 63\% + 40\%) / 6 = 54\%$ Average section loss in the lower web over 40" long area (Points A and G to J):  $(39\% + 21\% + 16\% + 25\% + 22\%) / 5 = 25\%$ **Notes:**

-As per the above sketch, the section loss in the lower web of the girder continues beyond 40" long from the girder end. No D-meter readings were obtained in this 20" long area due to the fact only the D-meter readings within the 40" long area were used for the overall web bearing area section loss (as per NYSDOT guidelines).

-Guide angle not shown in sketch due to clarity purposes to show section loss and D-meter readings in girder web. The guide angle is 19"H x 5"W starting approximately from the bottom of the girder web. The left guide angle exhibits 3"H x 4"W corrosion hole at the bottom, 4"H x 3"W corrosion hole at mid-height, and 3" diameter corrosion hole at top with knife edging adjacent to the holes and up to 40% section loss in remaining area for full height. The right guide angle exhibits 11"H x 3"W corrosion hole at the bottom and 4"H x 2"W corrosion hole at the top with knife edging adjacent to the holes and up to 60% section loss in remaining area for full height.

**Attachment Description: Flag Condition Sketch**

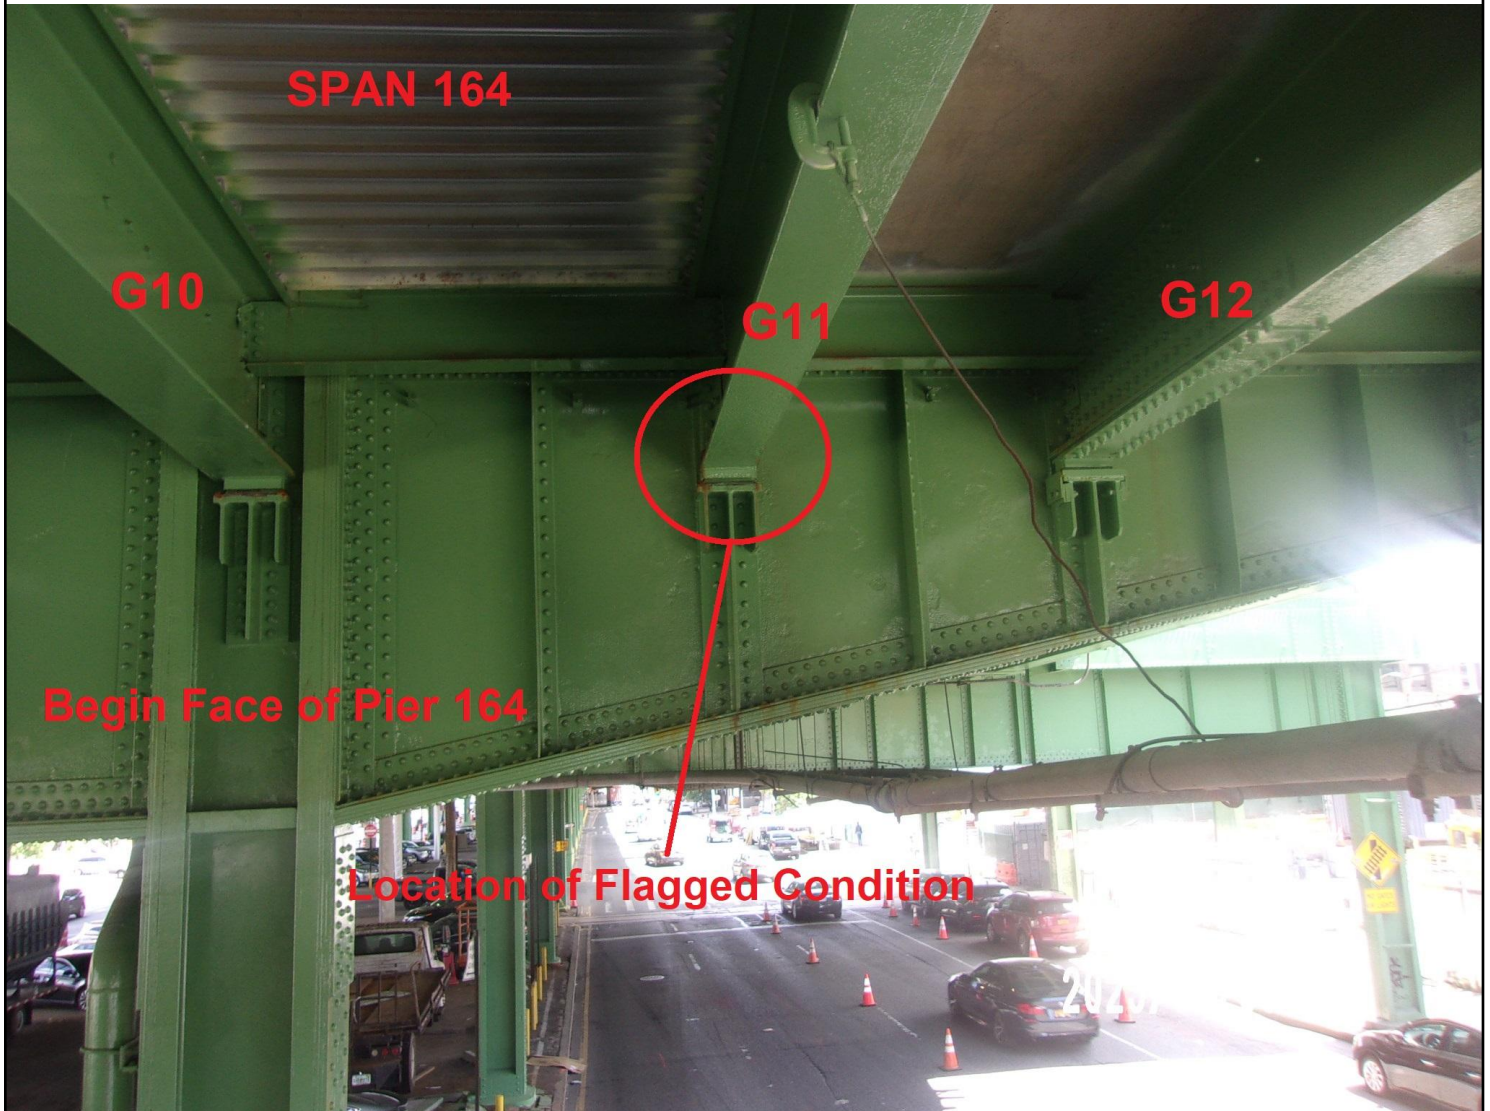
Photo Number: 3

**Attachment Description:** General view of the flagged condition at Girder G11 in Span 164 at Pier 164. Looking End.

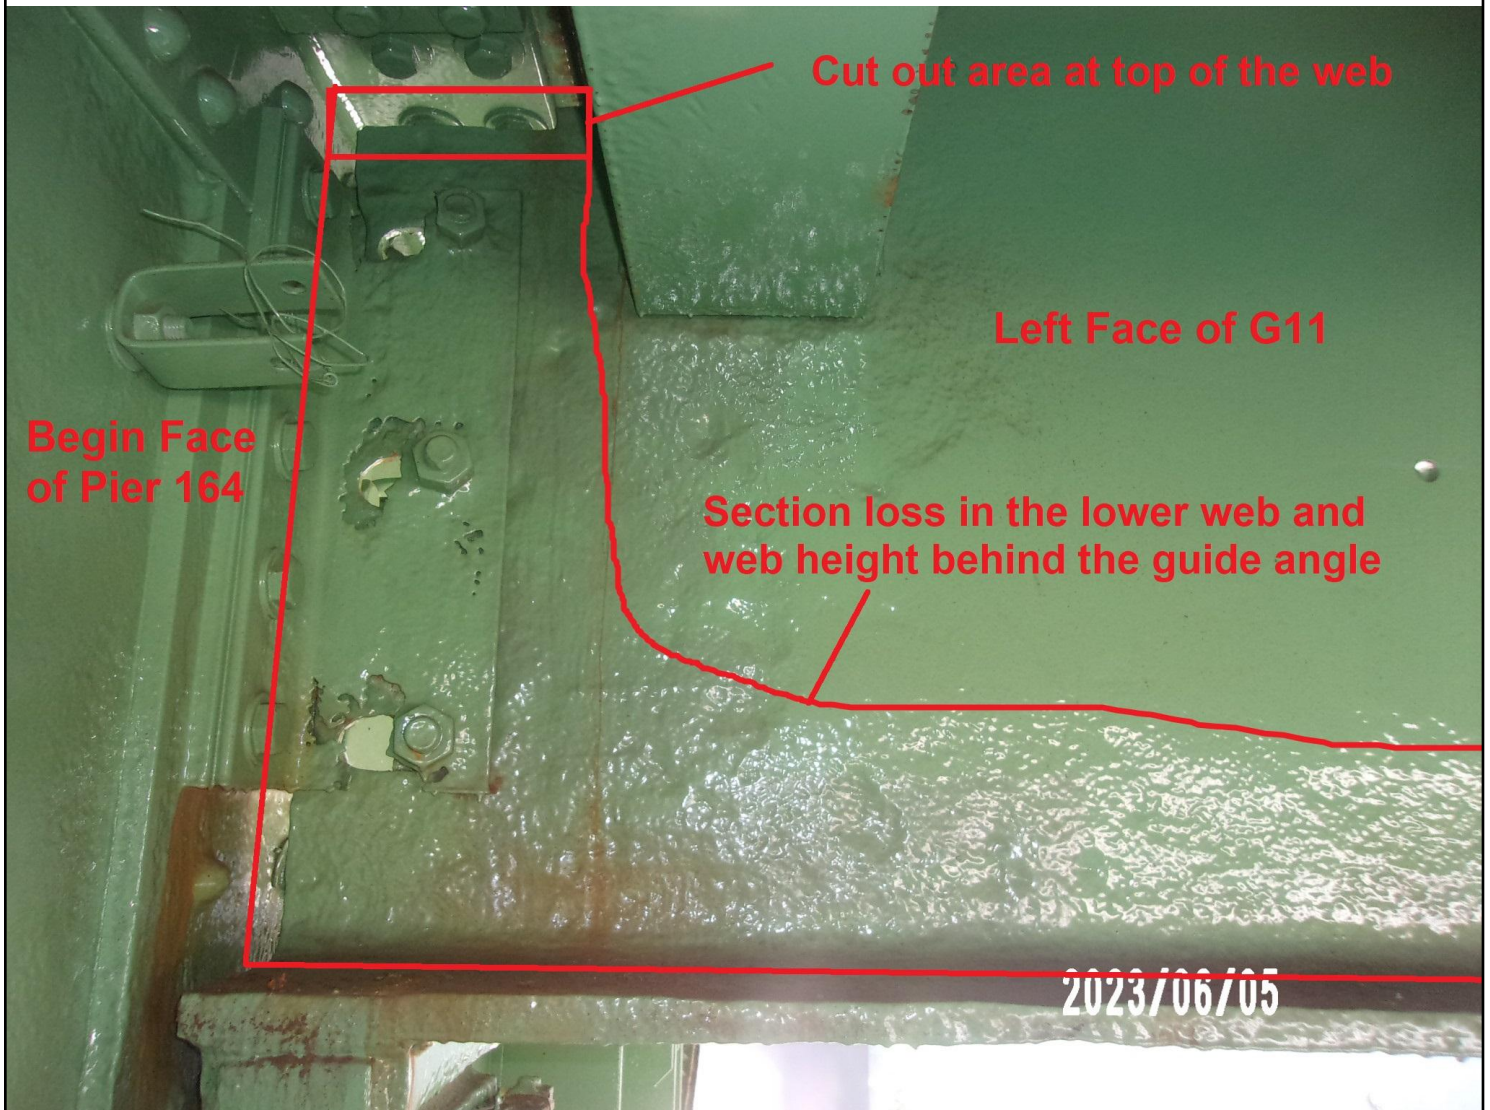
Photo Number: 4

**Attachment Description:** The left face of Girder G11 in Span 164 at Pier 164. The girder exhibits section loss for the full web height for 39%-70% section loss with average 54% section loss. The lower web exhibits 10%-25% section loss with 47% localized section loss in the web above the bearing. The top of the web exhibits a cut out area. Looking Right.

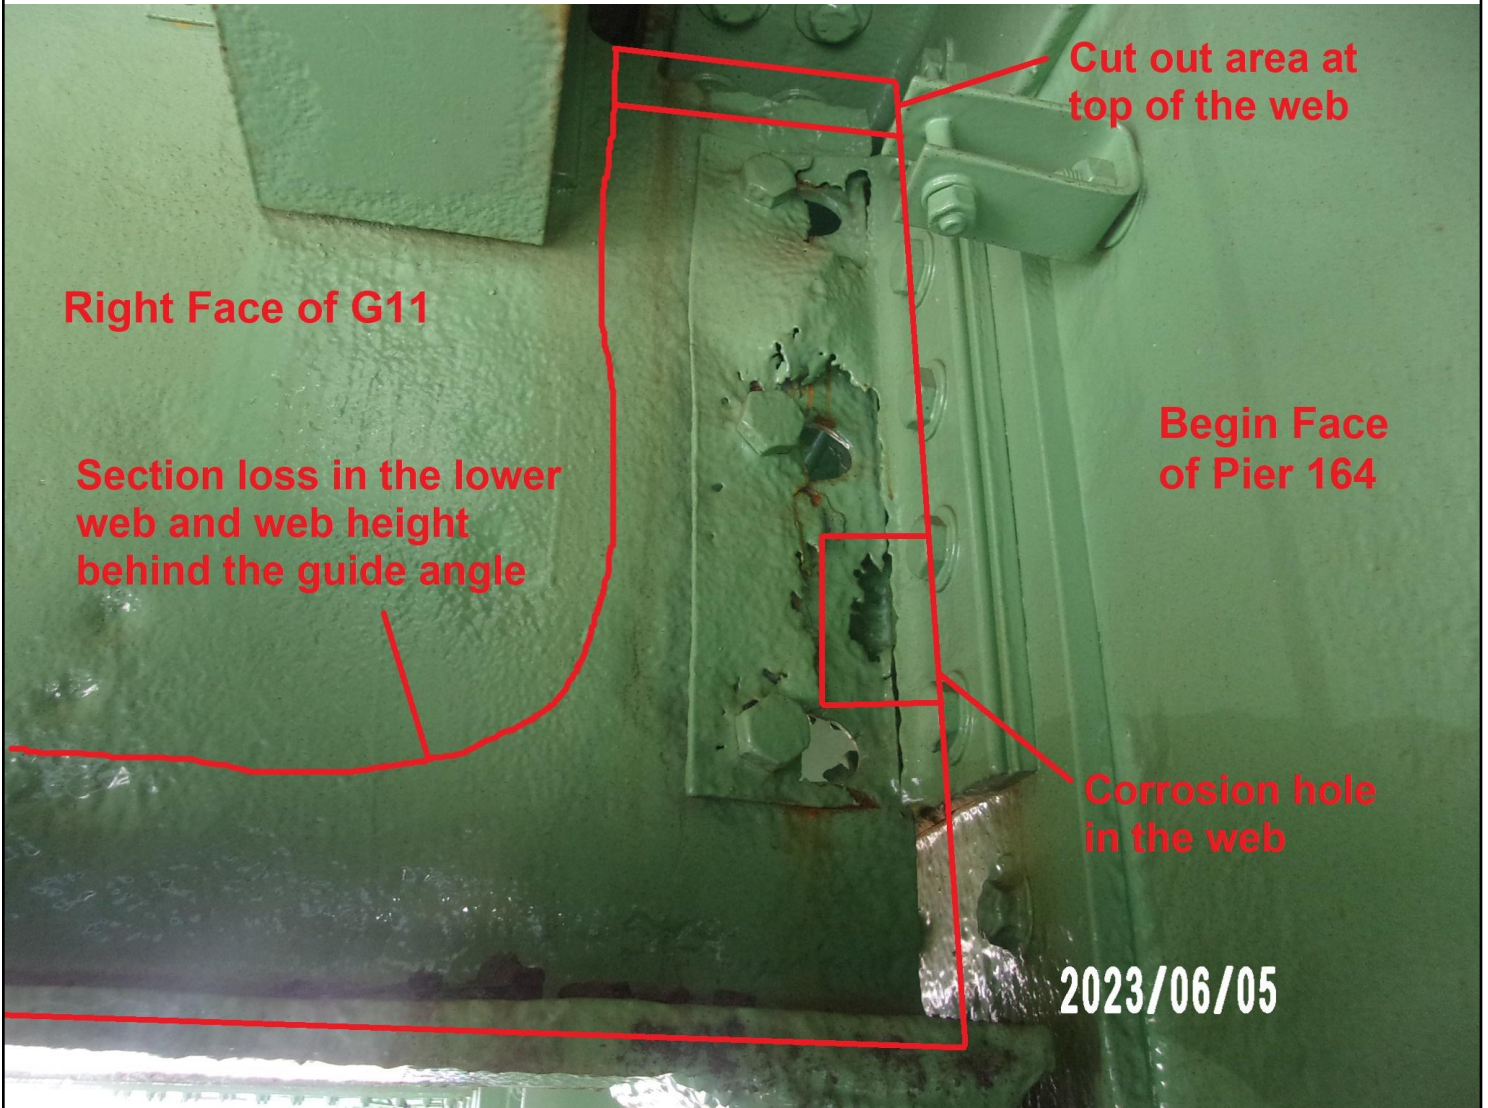
Photo Number: 5

**Attachment Description:** The right face of Girder G11 in Span 164 at Pier 164. The girder exhibits section loss for the full web height for 39%-70% section loss with average 54% section loss. The lower web exhibits 10%-25% section loss with 47% localized section loss in the web above the bearing. The girder web exhibits a corrosion hole behind guide angle. The top of the web exhibits a cut out area. Looking Left.

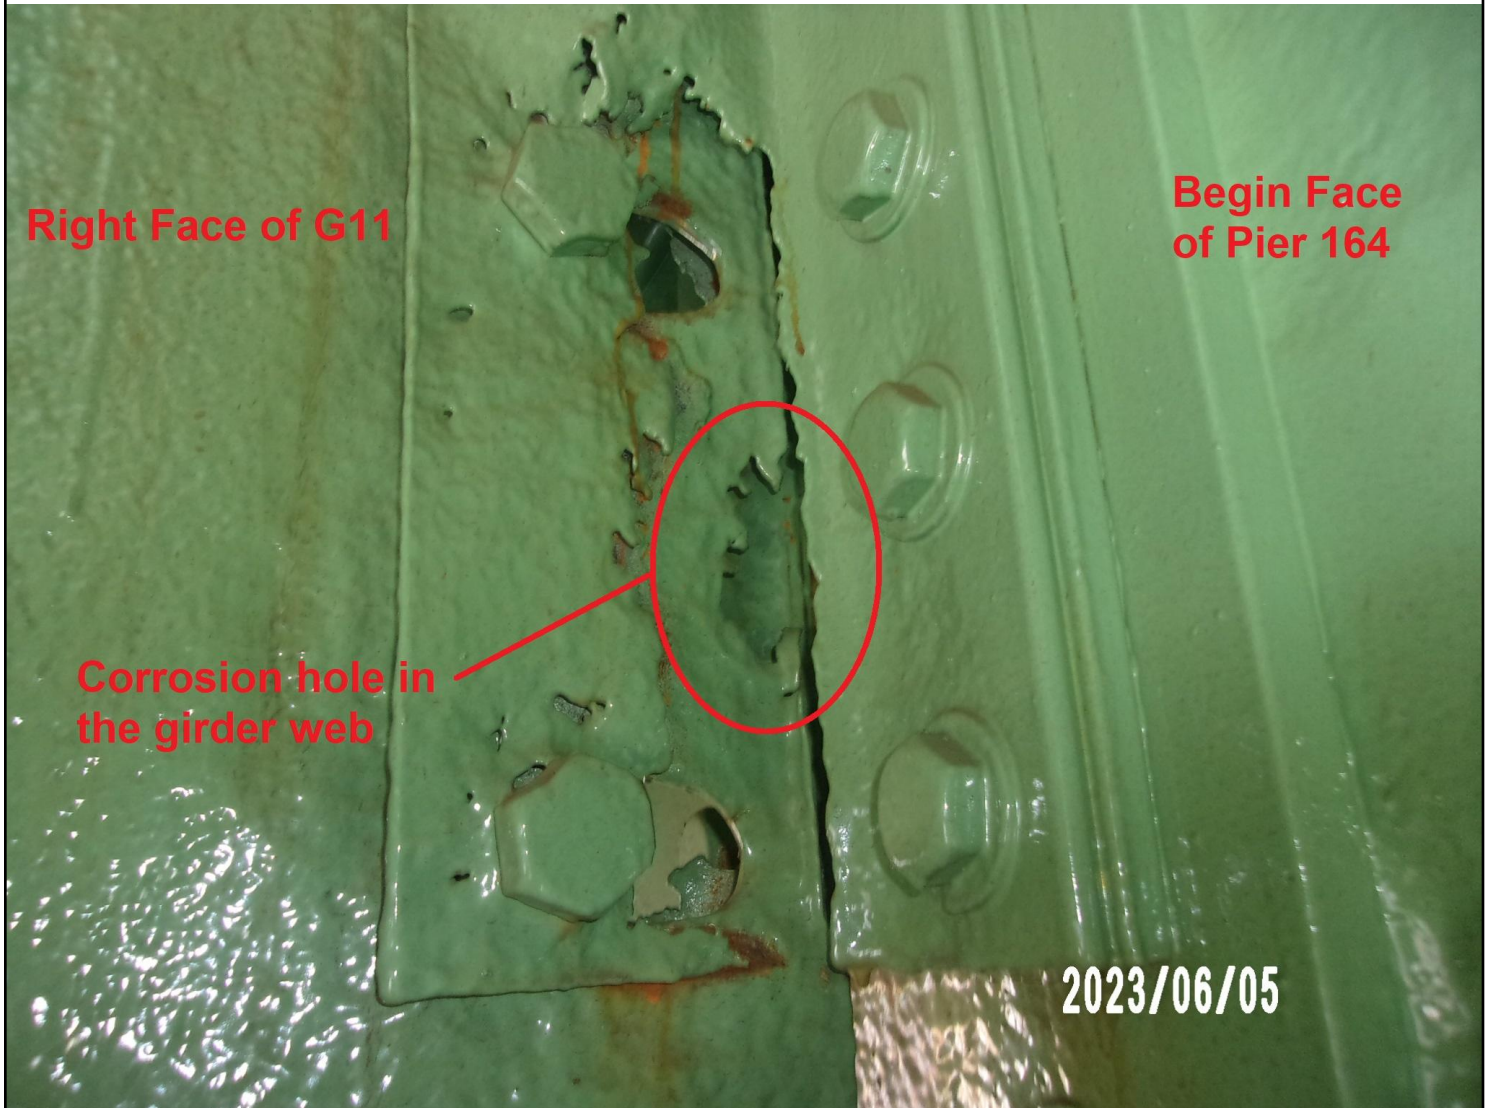
Photo Number: 6

**Attachment Description:** The right face of Girder G11 in Span 164 at Pier 164. Close up view of the 3"H x 1-1/4"W corrosion hole in the girder web behind the guide angle. Looking Left.

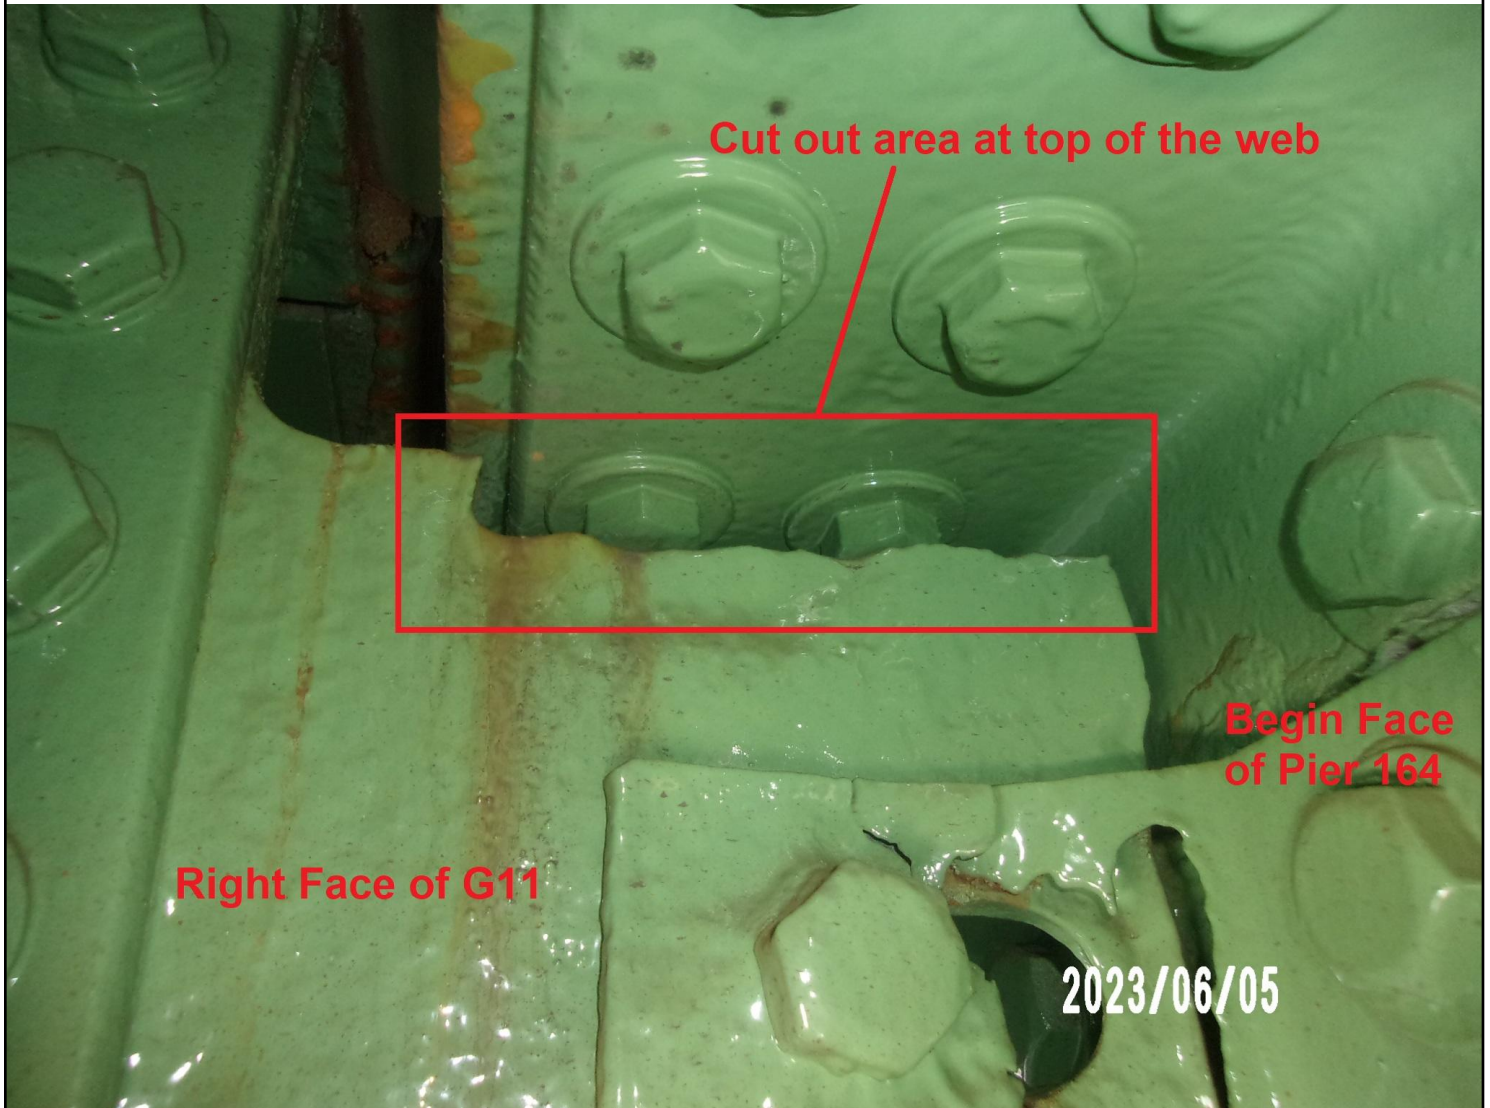
Photo Number: 7

**Attachment Description:** The right face of Girder G11 in Span 164 at Pier 164. Close up view of the 6-1/2"L x 1"H cut out area in the top of the girder web adjacent to the top cope. Looking Left.

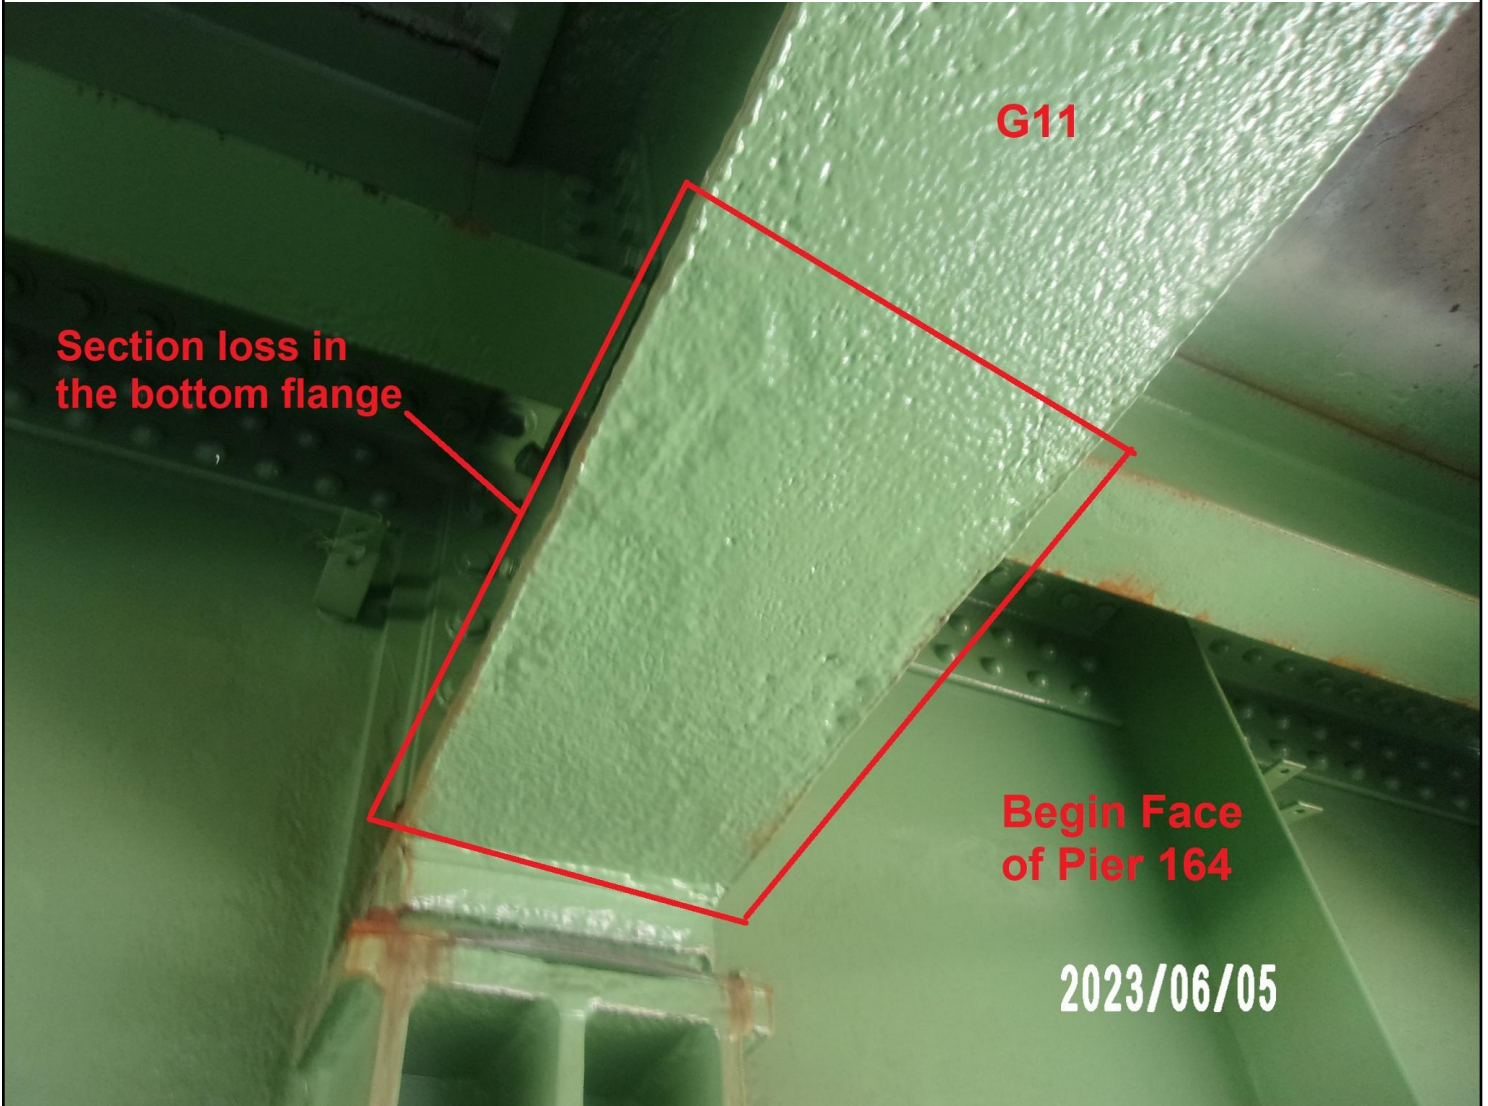
Photo Number: 8

**Attachment Description:** The underside of Girder G11 in Span 164 at Pier 164. The bottom flange exhibits up to 15% section loss for 24"L for the full width of the flange. Looking End.
